HAMBLE
MARINE
SURVEYS

Pre-Purchase Survey

1st February 2016

'Sealine F42/5'

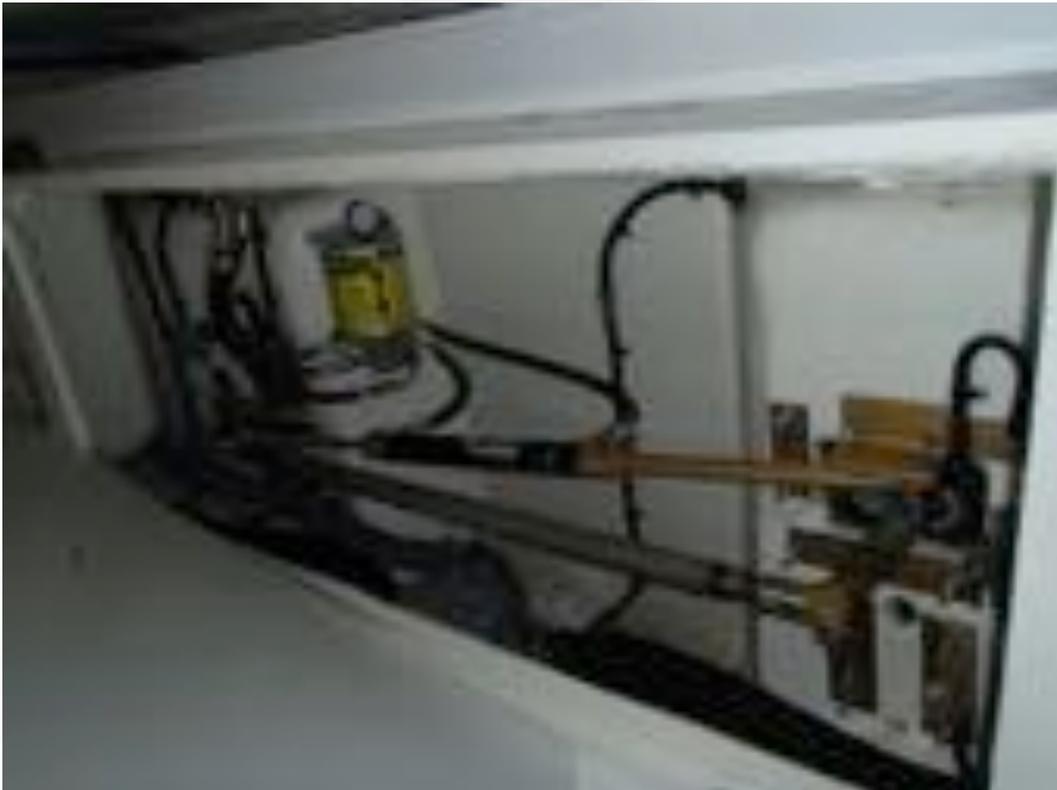
The steering ram, link rod, upper stock and arms were all found in sound condition.

Image of the aft steering arrangement for the starboard rudder unit.

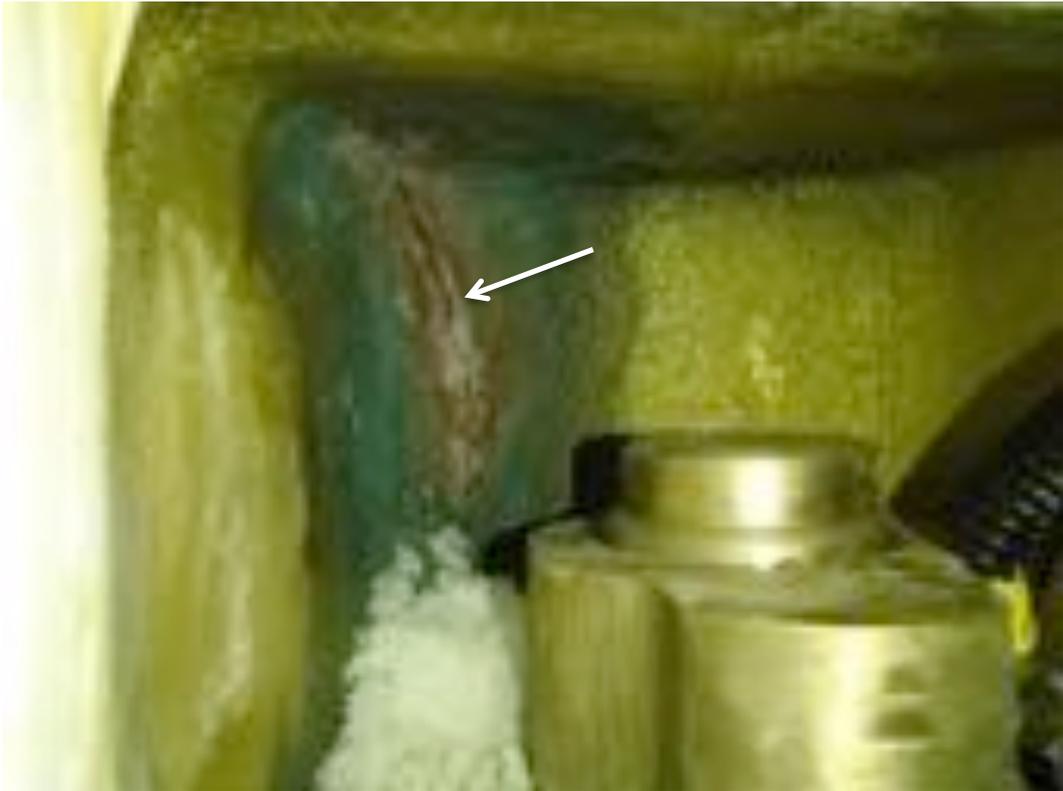
During a detailed inspection of the steering system it was noted that the cast alloy transom covers over the steering system to port appears to be weeping. A neat pile of salt crystals was noted in way of the port stock top. This appeared to correspond to a split in the casting. It is clear the split which is submerged will need further investigation. If the split cannot be repaired, then the alloy cover over the port steering will need replacing. Closer inspection of an image taken of the transom cover suggests a past repair has been undertaken. It is unclear what material has been used for the repair. The presence of salt crystals internally indicates the repair has been unsuccessful and the split continues to leak.

Image of the port stock and surrounding alloy cover. Note the weep form a suspected split in the cover.

- 1. It is recommended that the suspected split in the alloy cover and resultant ingress in way of the port rudder stock be further investigated. The presence of a past repair to the cover externally on the transom would appear to suggest the current owner is aware of this issue. The repair has been unsuccessful and it is likely that the cover will need replacing or re-repairing. (A) Repair completed 16/02/16.*

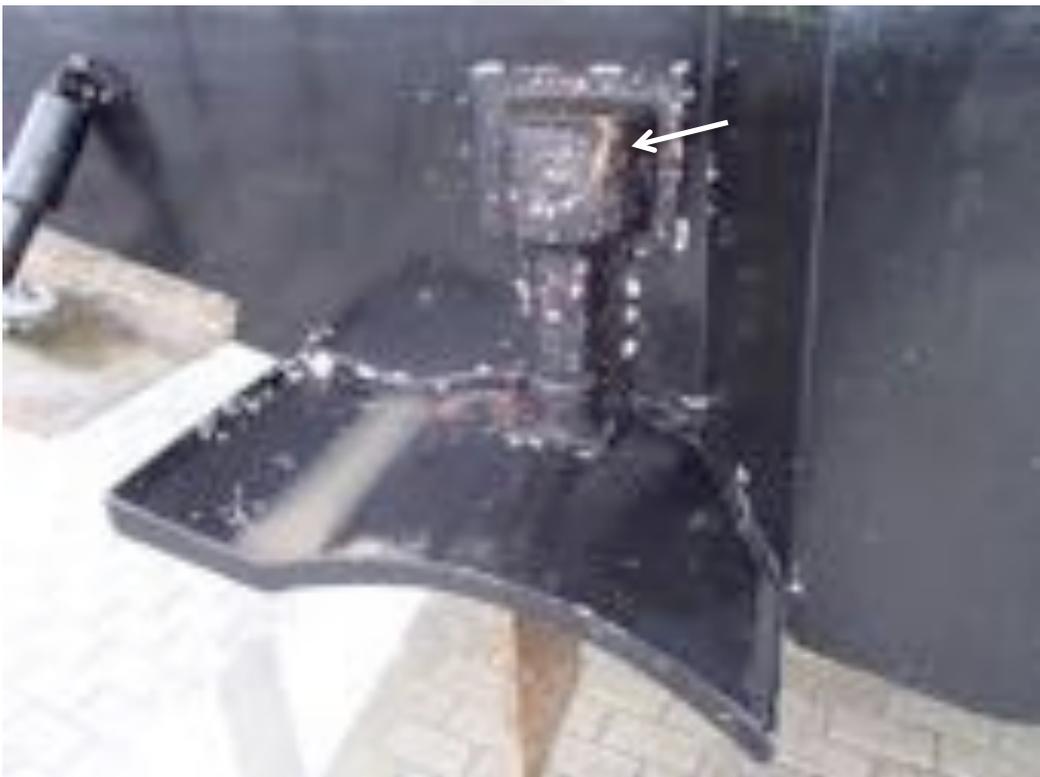
Image of the transom cover. Note evidence of a past repair.

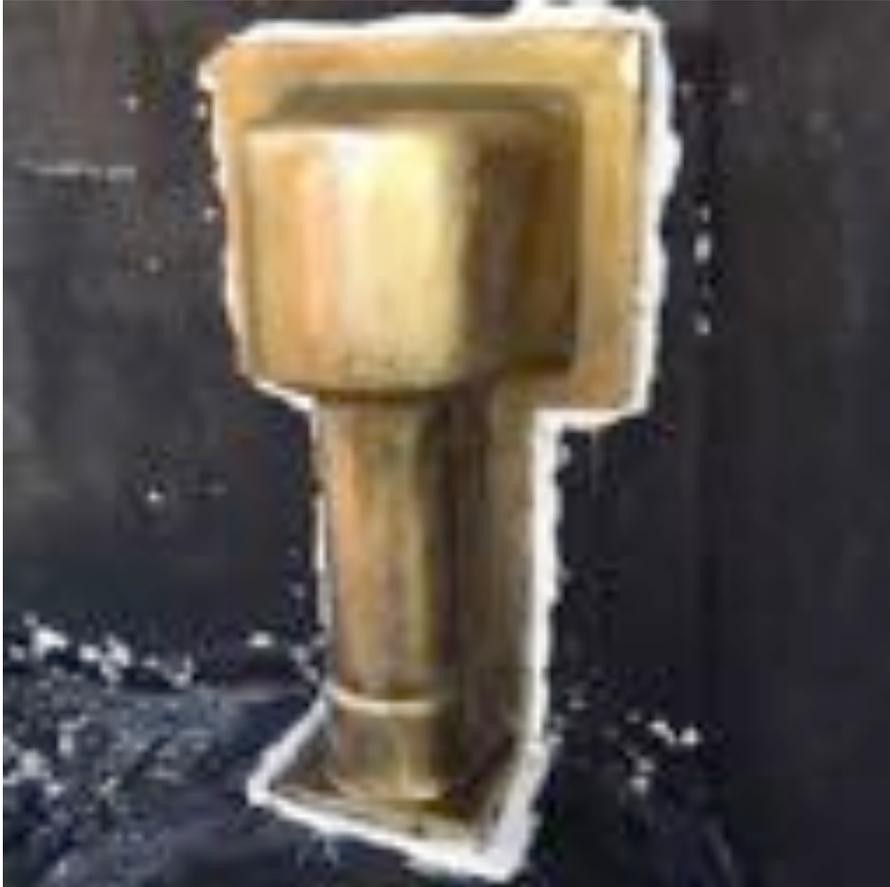
On the 16th February 2016 confirmation was received that the transom cover had been repaired with the vessel ashore at Hamble Yacht Services. Below image of the completed repair.

Image of the repaired transom cover.

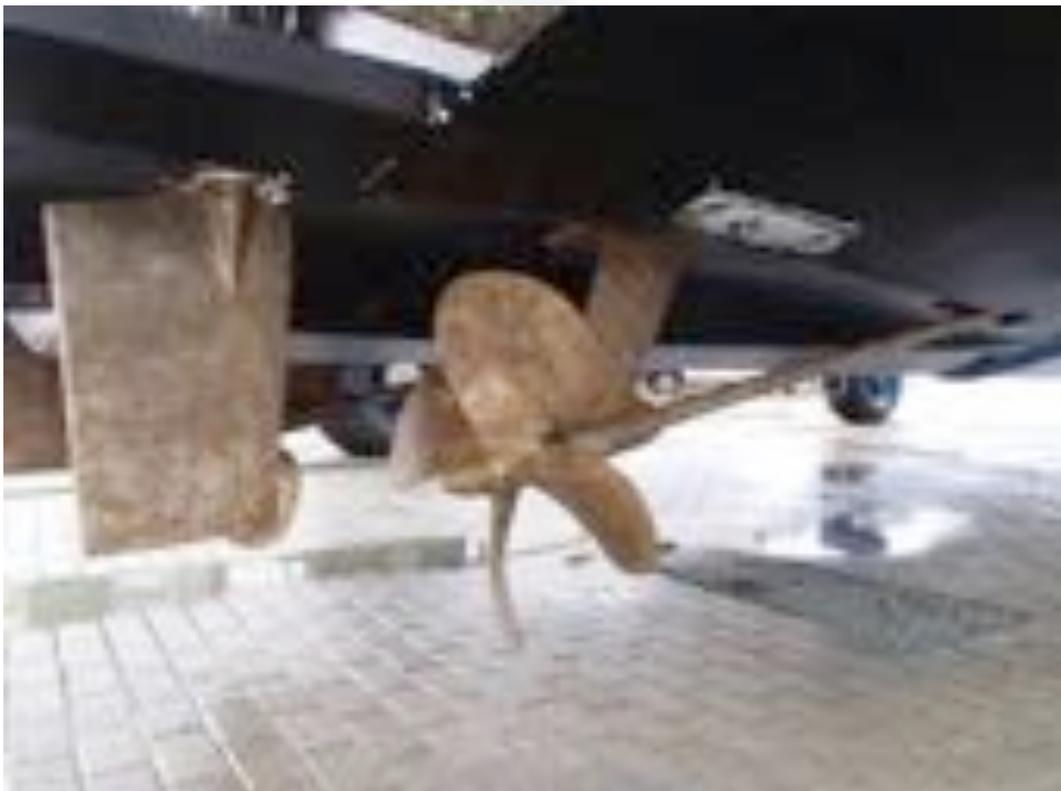
Both propeller shafts, P-brackets and propellers were inspected. All were noted sound with light surface scaling from marine fouling. All would benefit from polishing.

Image of the starboard shaft, P-Bracket, rudder and propeller.

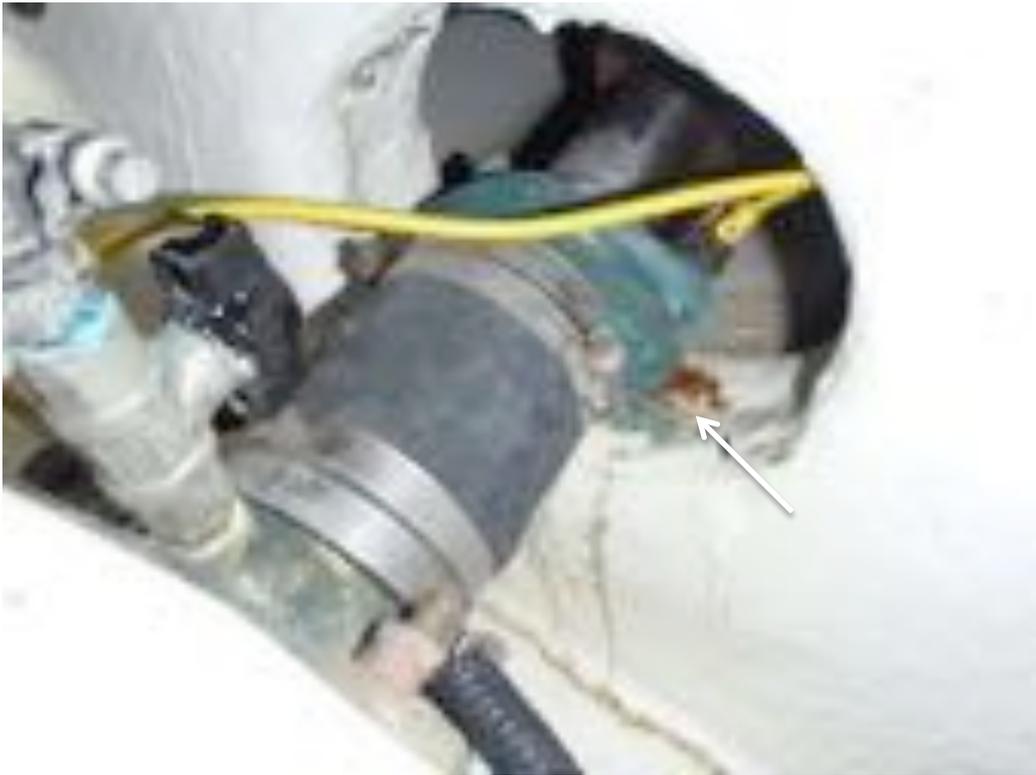
Water cooled stuffing box type stern seals were inspected accessible from the aft end of the engine compartment. Both were found in fair condition with evidence of past weepage and surface corrosion. Both seals will need servicing and close monitoring.

Port shaft seal. Note the surface corrosion developing and weep at the base.

- 1. It is recommended that both shaft seals be serviced and the corrosion cleaned back and closely monitored. (B)*
- 2. It is suggested that the stern gear all be cleaned and polished. (C)*

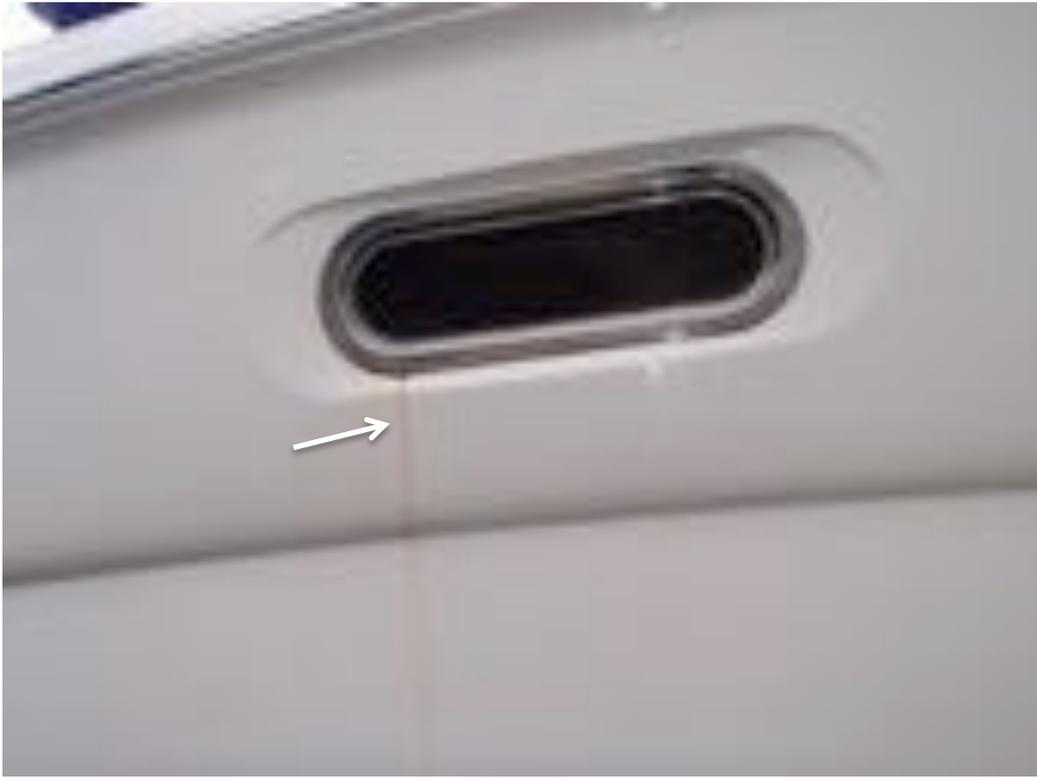
It was noted that the forward two hull portlights to starboard has rust streaking down the topsides. This may indicate that the securing bolts around the portlight are corroding. This will need further investigation.

Image of the starboard forward portlight. Note the rust streaking.

- 1. It is recommended that the source of the rust streaking from the two forward starboard hull portlights be investigated further. (B)*

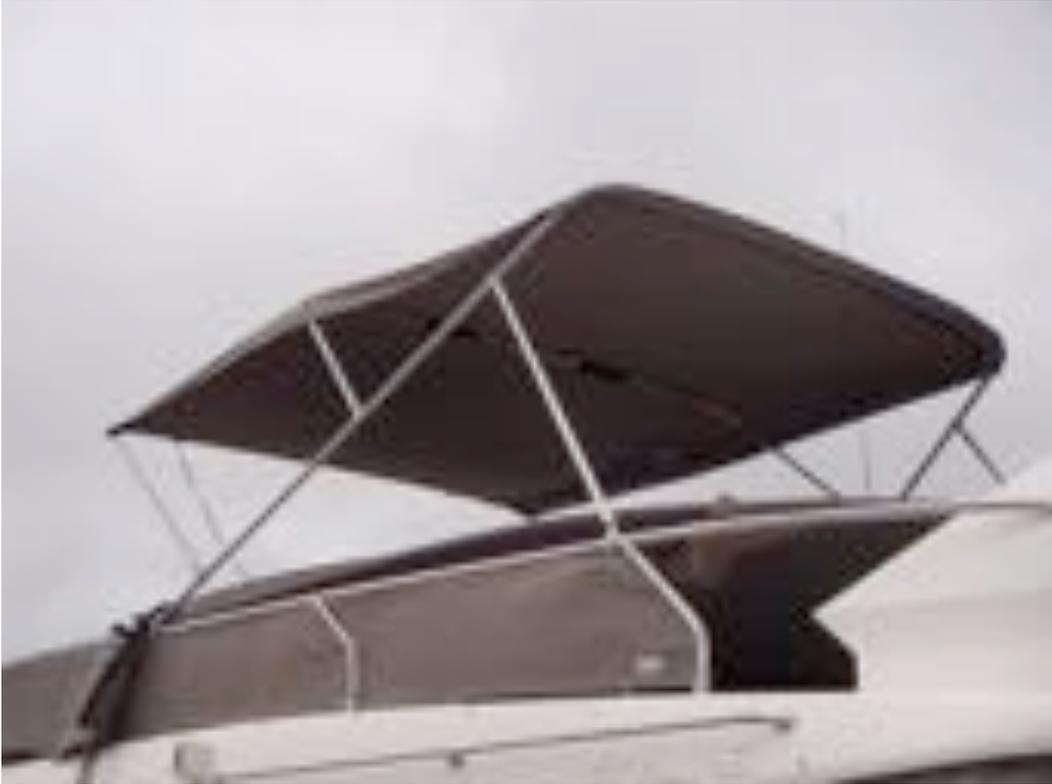
A bimini cover was noted over the flybridge. The cover was stowed away at the time of the survey. The protective cover is in need of cleaning. The cover itself was in fair condition.

Image of the bimini.

- 1. It is suggested that all canvas covers and seat covers be cleaned and serviced. The securing poppers down both sides of the flybridge will need re-securing where coming loose. (C)*

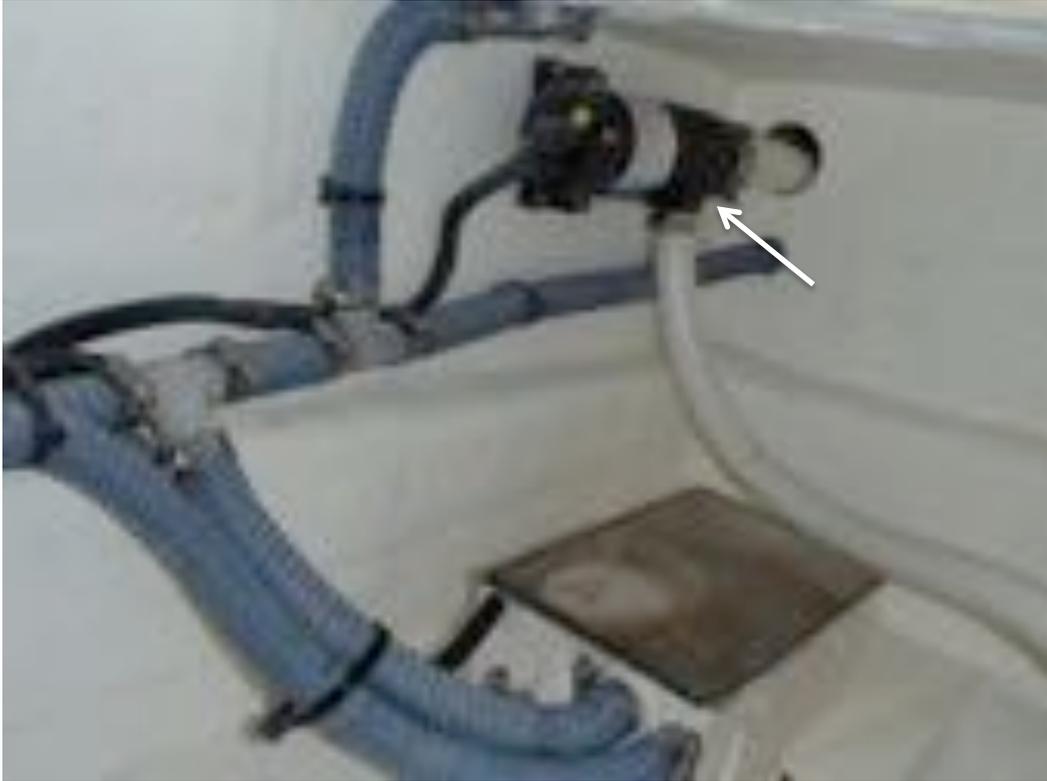
The macerator pump was switch tested and found to operate although it produced an unhealthy noise suggesting the impeller in the pump may be damaged or detached. The pump appears to no longer function as designed.

The holding tank appears to be full.

Image of the macerator pump which was found to be defective.
