HAMBLE
MARINE
SURVEYS

Pre-Purchase Survey Fairline Turbo 36 'Mr Brightside'

Ocean Village Marina
21st July 2022

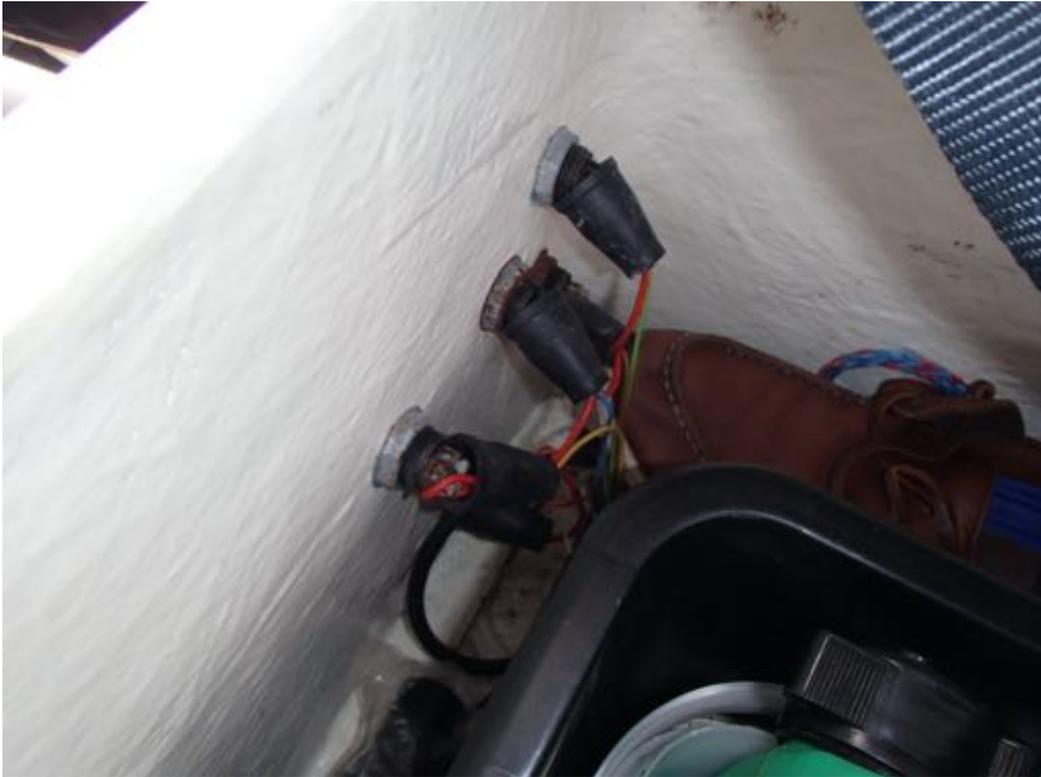
- c) A hydraulic passerelle was noted transom mounted. The unit was operated via push buttons to the side of the moulded aft cockpit seat unit. The rubber covers over each button was perished. The wiring at the rear of each button is exposed to damage and in several cases showing signs of corrosion.
- d) The motor for the hydraulic system for the passerelle was noted under the aft cabin berth. Strangely a dedicated 60Ah battery has been paced under the aft cabin berth for the passerelle. The battery is un-secured and a second identical battery also present also unsecured, but also unconnected.
- e) No transom platform swim ladder was noted.

Image of the exposed and corroded switches for the passerelle.

- 1. It is recommended that the passerelle battery be secured and the spare un-connected battery removed if redundant. The passerelle switches will all need attention and protection from within the stowage locker. (B)**
- 2. It is suggested that a swim ladder be provided. (C)**

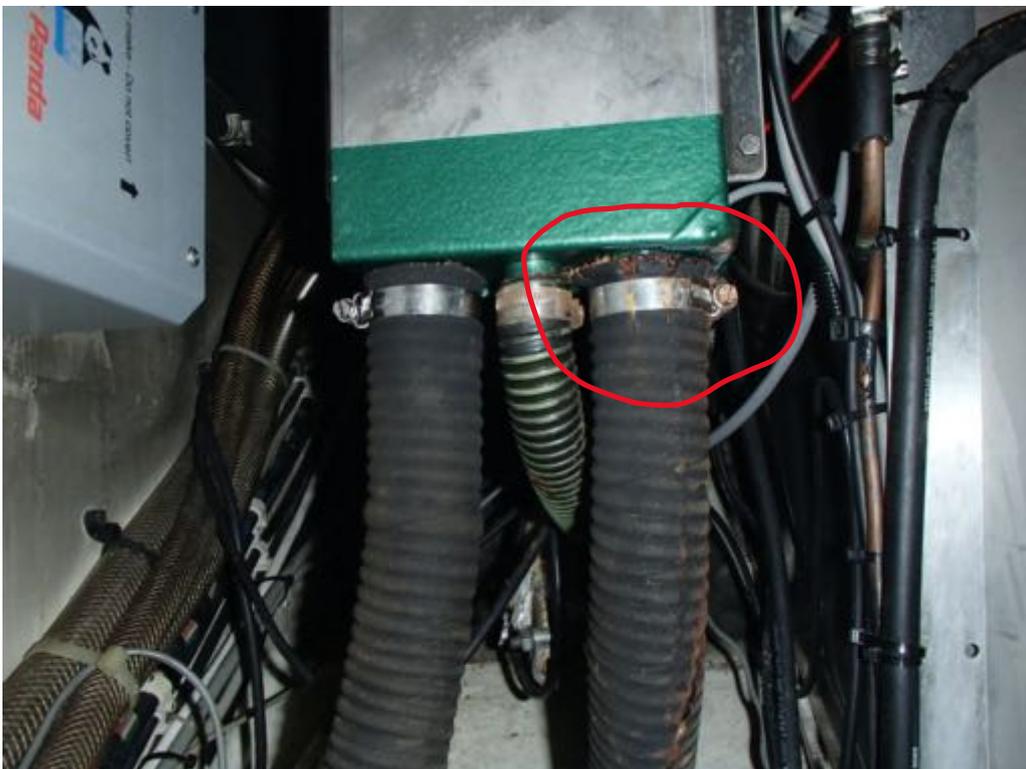
- d) The fuel and water supply to the generator was sound. The exhaust and water separation appears original to a previous generator installation. The hose between the water trap and water separator is perished and a leak noted.

Image of the exhaust separator for the generator. A leak was noted.

- 1. It is recommended that where possible service history and past records be obtained for the engines and generator. The generator exhaust hose between the muffler and water separator should be replaced and the suspected leak rectified. (B)**
- 2. It is recommended that the engine extinguisher be replaced for a suitable and compliant unit. (B)**
- 3. It is recommended that the exhaust skin fittings visible in the aft cabin to each side of the transom be removed, cleaned and re-fitted and sealed as both have evidence of past weeping. (B)**
- 4. It is recommended that the bolts securing the engine bearers where visible and noted in the aft cabin above each shaft seal be replaced as they are badly corroded. (B)**
- 5. It is recommended that the saloon helm throttles be re-secured. (B)**

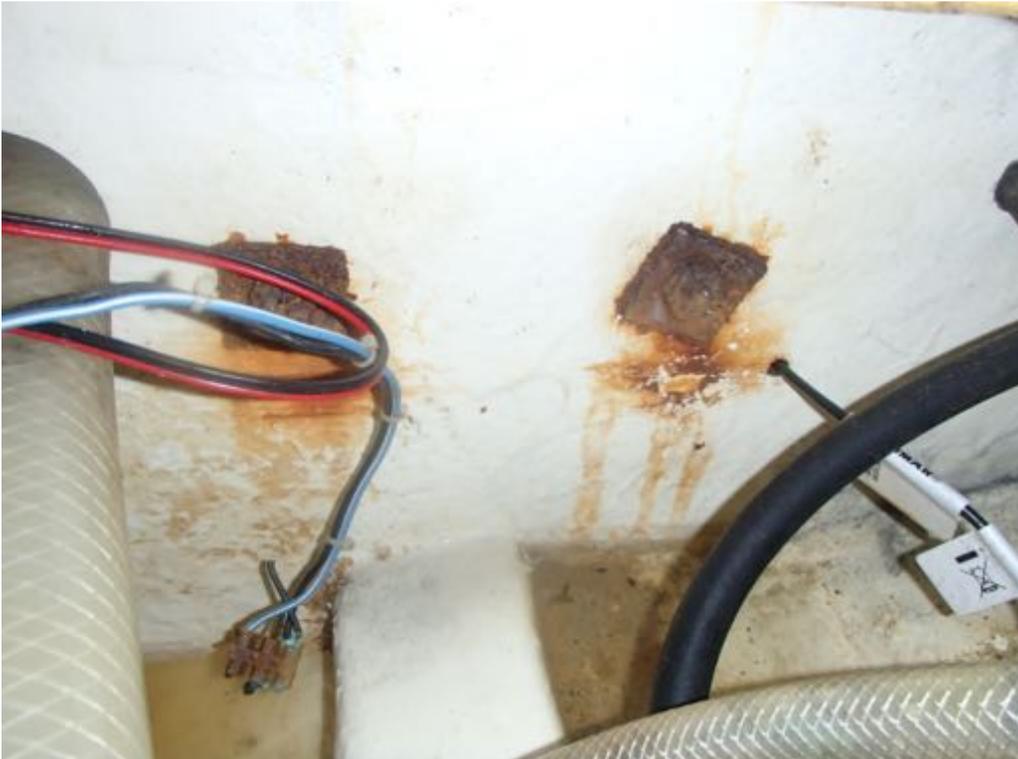
- f) The engine bearers appear bolted forward and aft to the compartment bulkheads. The bolts securing the aft end of the bearers visible above the respective shaft seals appear corroded. The bolts may require all replacing.

Image of the corroded bolts on the aft face of the bulkhead for the engine bearers.

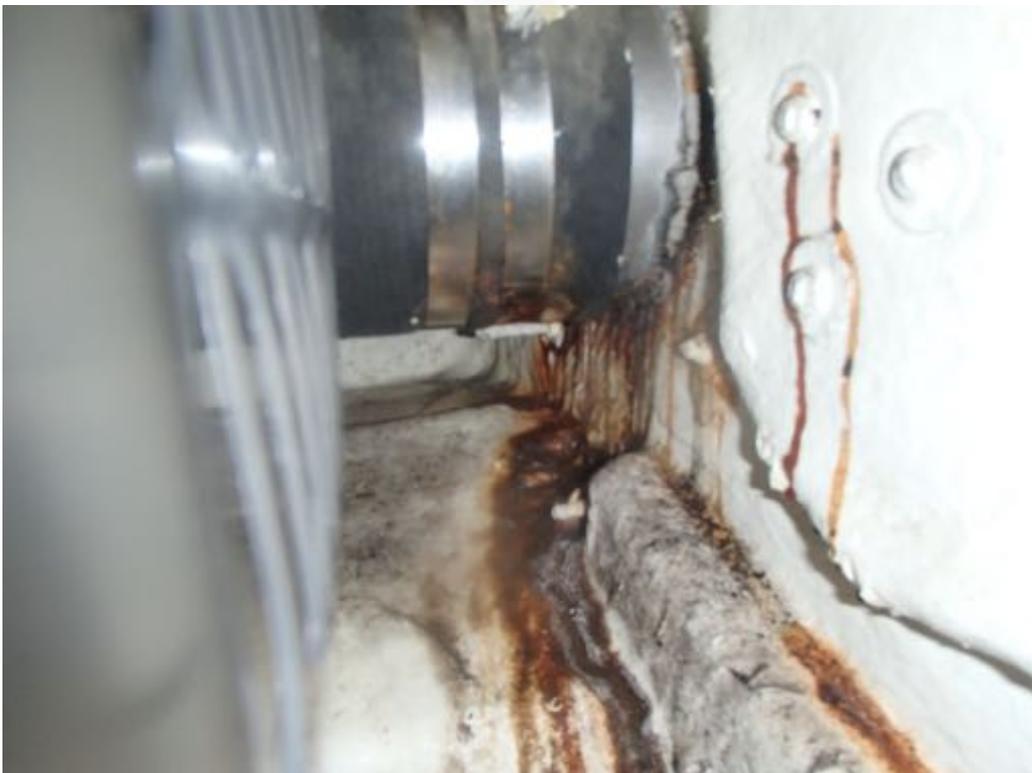
- g) The exhaust hoses from both engines were noted to pass down both sides of the vessel and exist back aft just below the waterline. On both sides of the hull the skin fitting has rust streaking and corrosion developing suggesting both are weeping. This is a common observation on the Turbo 36, but in both cases the hoses should be removed, areas cleaned and re-fitted and sealed.

Image of the starboard aft engine exhaust hose weeping where secured to the transom fitting.

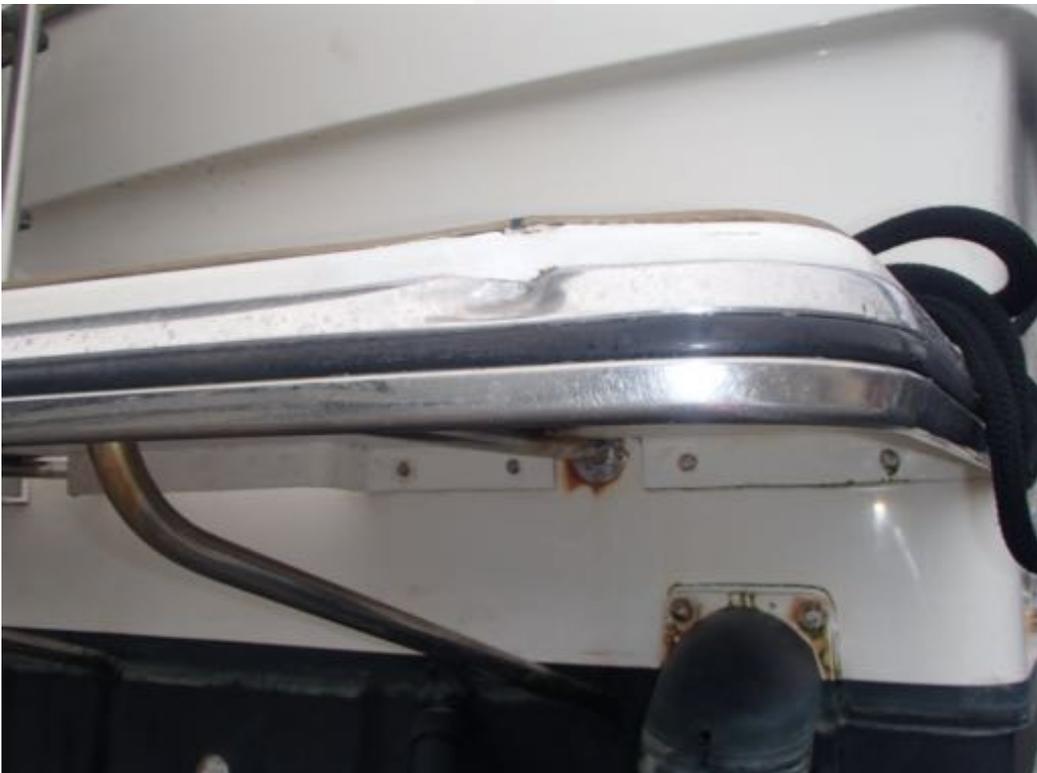
- a) The topsides were presented in a white pigmented gelcoated finish. The topsides were inspected and lightly hammer tap-tested and no signs of obvious delamination or production faults were detected.
- b) The topsides were in good condition with no significant damage noted. Minor marks and blemishes were noted.
- c) The topsides have clearly been very well maintained and routinely polished over the years. Only on-going cleaning and polishing is required at this time.
- d) A swim platform is bolted to the transom. The transom moulding is presented in a white gelcoat finish. Minor marks and blemishes were present with an area of contact damage noted to starboard. The damage is full thickness including the trim being dented. While cosmetic the damage is unsightly and will need to be repaired.

Image of the contact damage to the platform to starboard.

1. It is recommended that the damage to the starboard aft edge of the transom platform be repaired. (B)

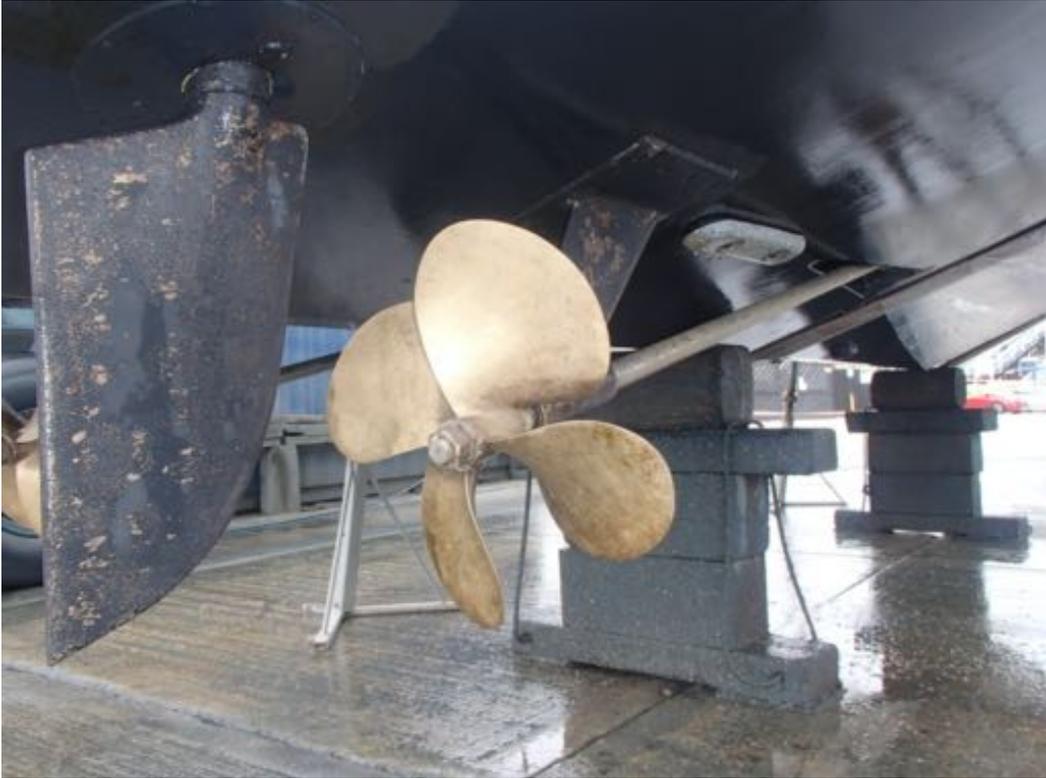
Image of the starboard stern gear post jet wash cleaning.
