HAMBLE
MARINE
SURVEYS

Pre-Purchase Survey Southerly 35RS 'Vela Spirit'

Chichester Marina
22nd August 2022

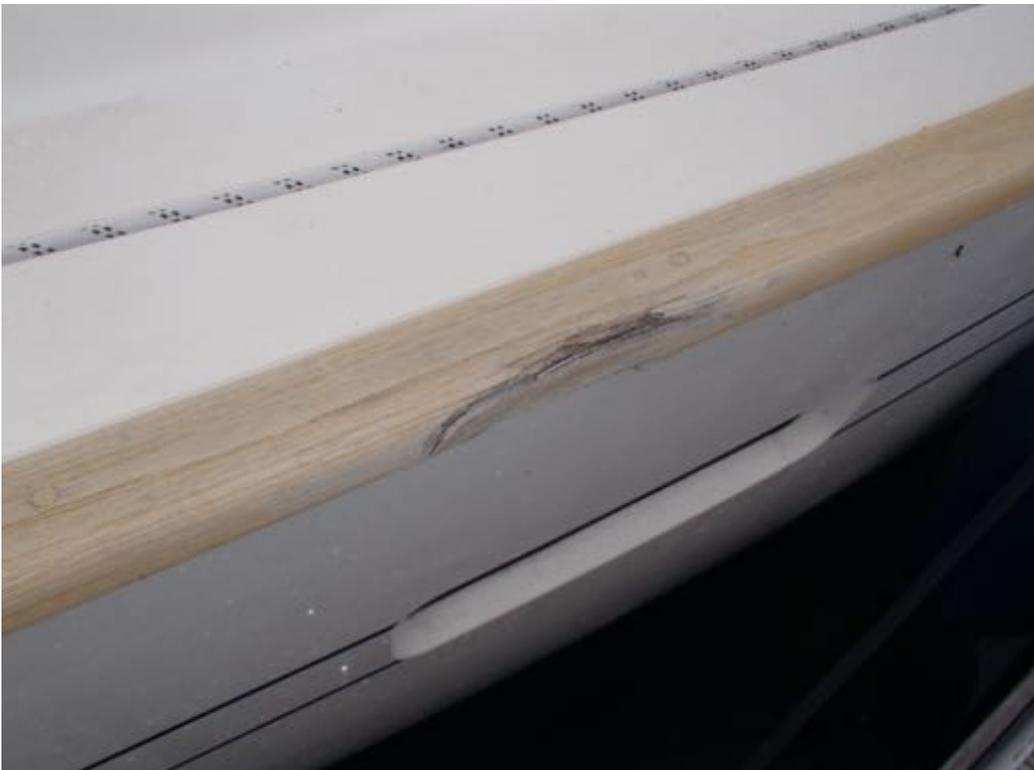
Image of damage noted to the port toe rail

- 1. It is recommended that the port side toe rail capping be repaired as contact damage exists. Any repair undertaken will need to match the surrounding toe rail capping. (B)***

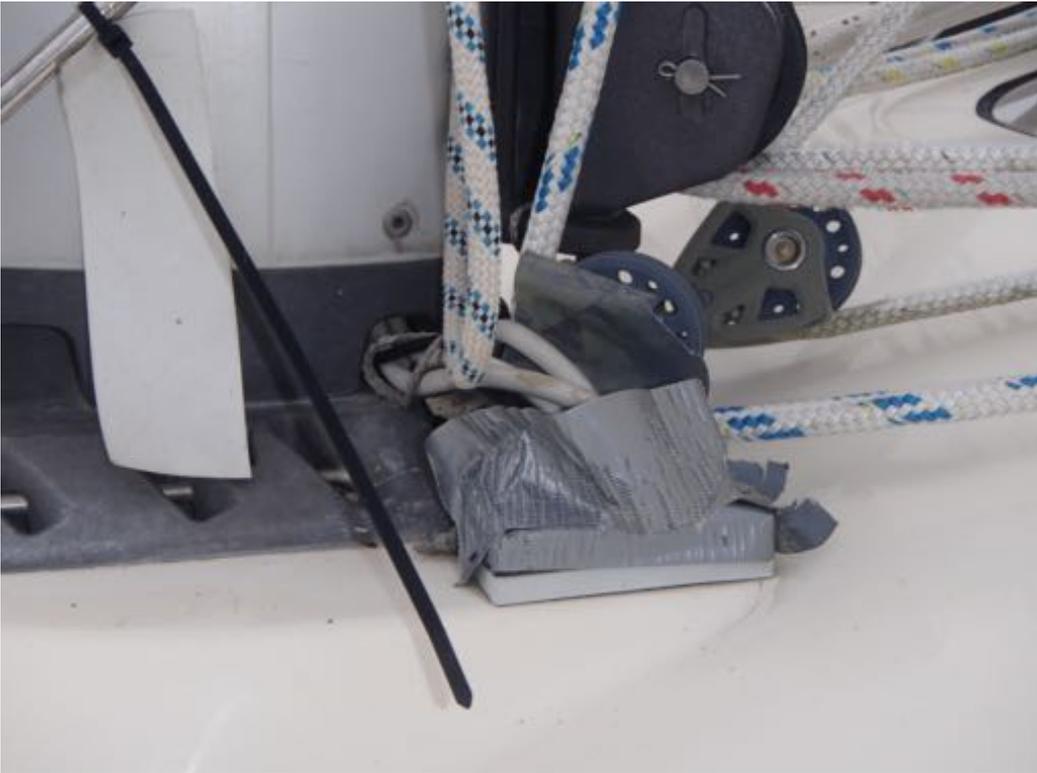
Image of the mast electricals deck gland noted over taped

- 1. It is recommended that the deck gland for the mast cabling be re-sealed with the current tape removed. (B)**
- 2. It is suggested that the mooring cleat rub strips be checked as they have not been mounted flush and so maybe causing wear to the mooring lines. (C)**

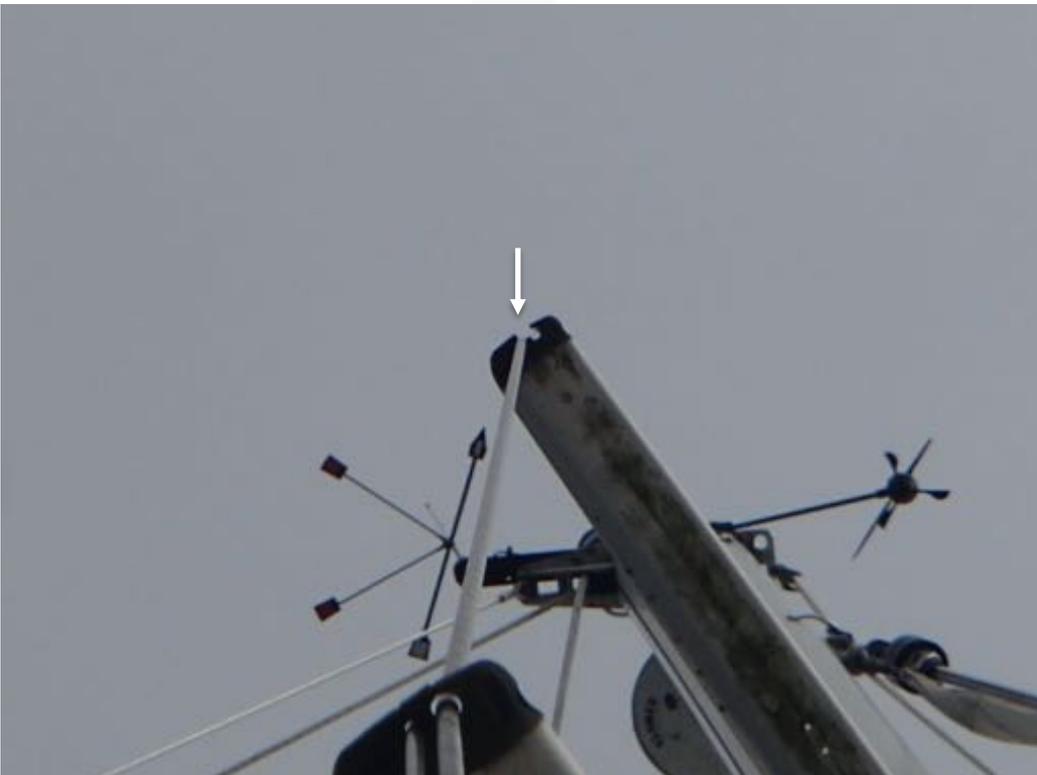
Image of what appears to be a missing cap over the spreader end

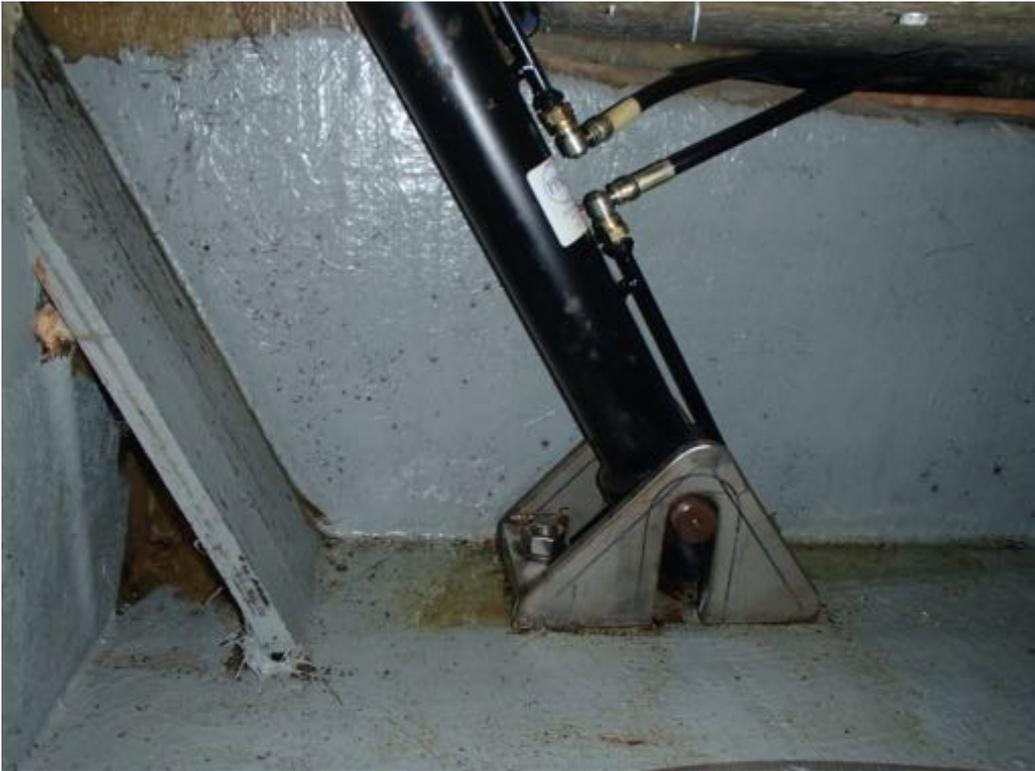
- g) The hydraulic pump and ram were visible under the saloon sole. The oil reservoir appears low in oil and oil noted under the ram itself. Also around the top of the ram corrosion was noted and evidence of oil leaks.

Image of the base of the swing keel hydraulic ram. An oil leak was noted.

- 1. It is recommended that the swing keel system be fully serviced. The keel will need abrading back to bare metal before a suitable coating system is re-applied. The hydraulic ram will need servicing as corrosion and an oil leak were noted. The keel box externally will need to be cleaned and the rubber side collars replaced. Finally, the cordage attached to the ram if over 5 years old will need close inspection possibly replacing. (B)**
- 2. It is recommended that the gauge indicating the swing keel position when raised and lowered be replaced as several of the lights are not working. (B)**

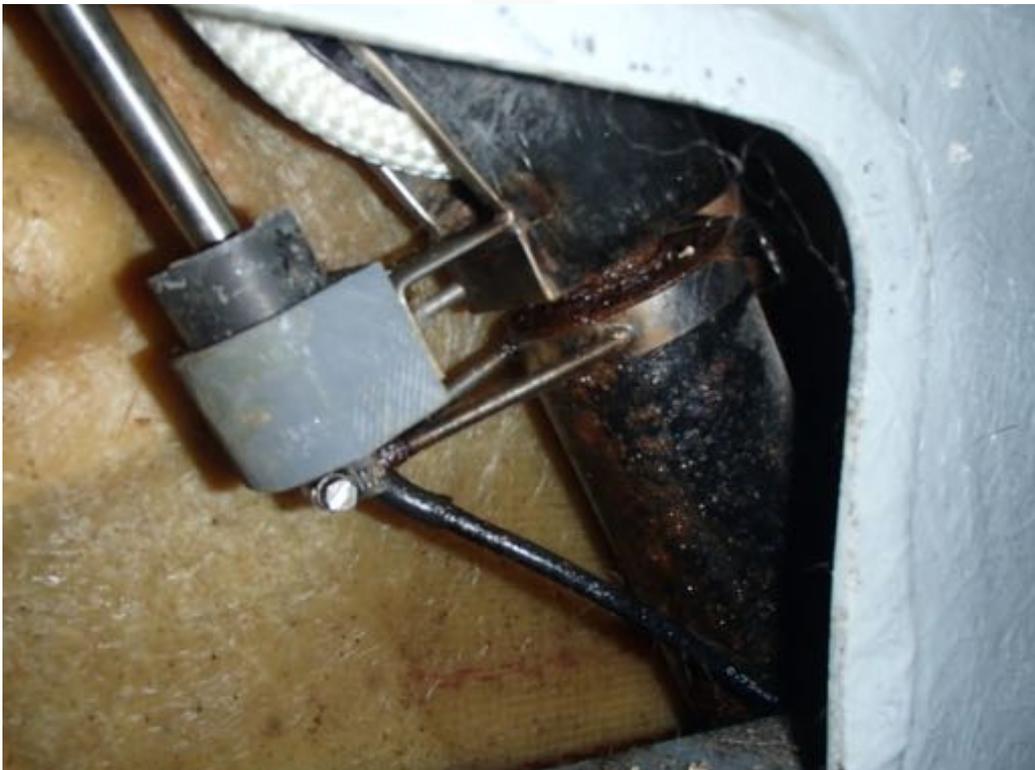
Image of the top of the swing keel ram. Note the corrosion and dampness caused possibly by an oil leak

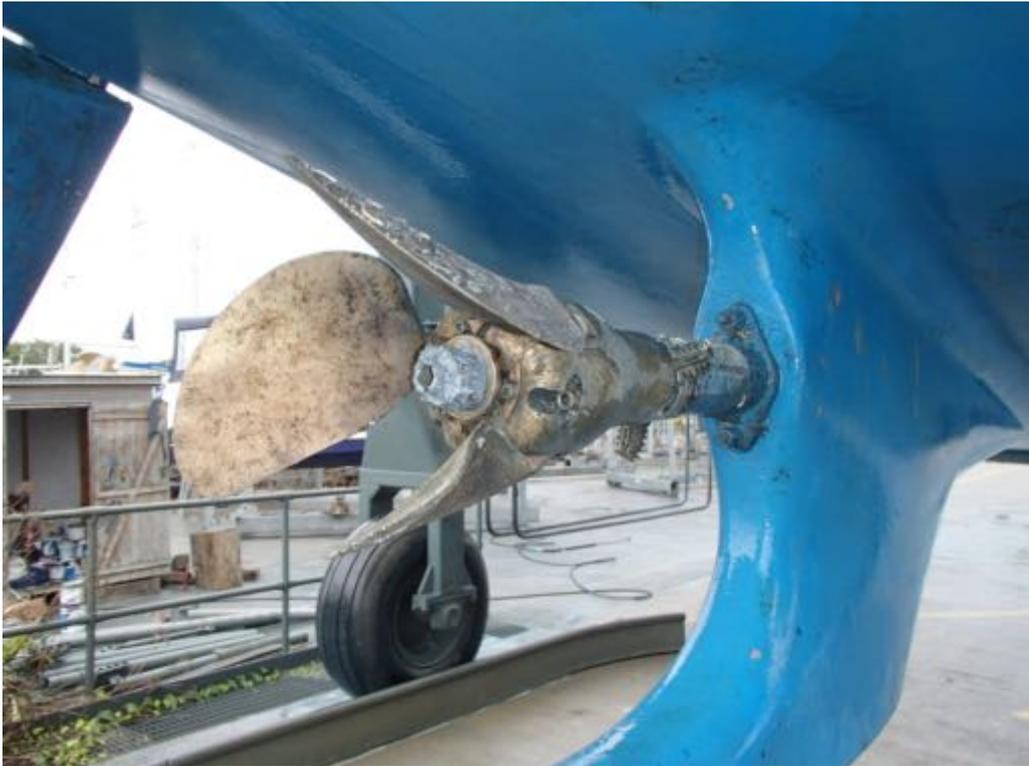
- a) A cone shaped anode was noted secured to the propeller. The anode while still secure is over 80% wasted and in need of replacement.
- b) A single hull anode was noted. The anode is approximately 20% wasted. The studs securing the hull anode are corroded. The hull anode appears bonded to the engine.
- c) A small anode was noted on the starboard side of the bow thruster. The anode was approximately 20% wasted.

Image of the stern gear. Note the wasted propeller anode

1. It is recommended that the anodes be replaced annually. The propeller anode will need replacing in the next 8 weeks at the latest. It is further

recommended that the studs securing the hull anode be replaced as both are corroded. (B)

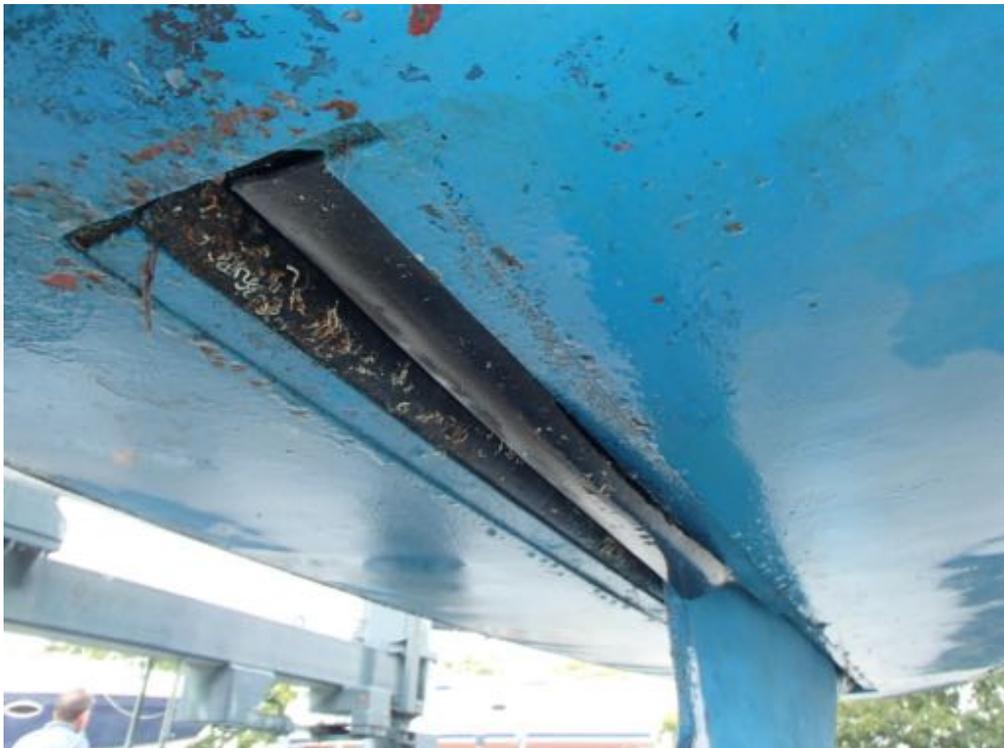
- e) Externally the aperture of the keel box was noted heavily fouled with marina growth and to each side of the aperture a rubber collar was noted. The collar was torn and hanging down to starboard. Both rubber collars require replacement and the keel box cleaned out.

Image of the keel box aperture. Heavy fouling was noted around and inside, and the rubber collars either side were damaged

- h) It is clear the keel mechanism requires a full service with the keel box cleaned out, rubber side collars replaced, the hydraulic rams serviced and the display at the binnacle replaced. If the cordage attached to the ram end is over 5 years old then this will require replacement also.

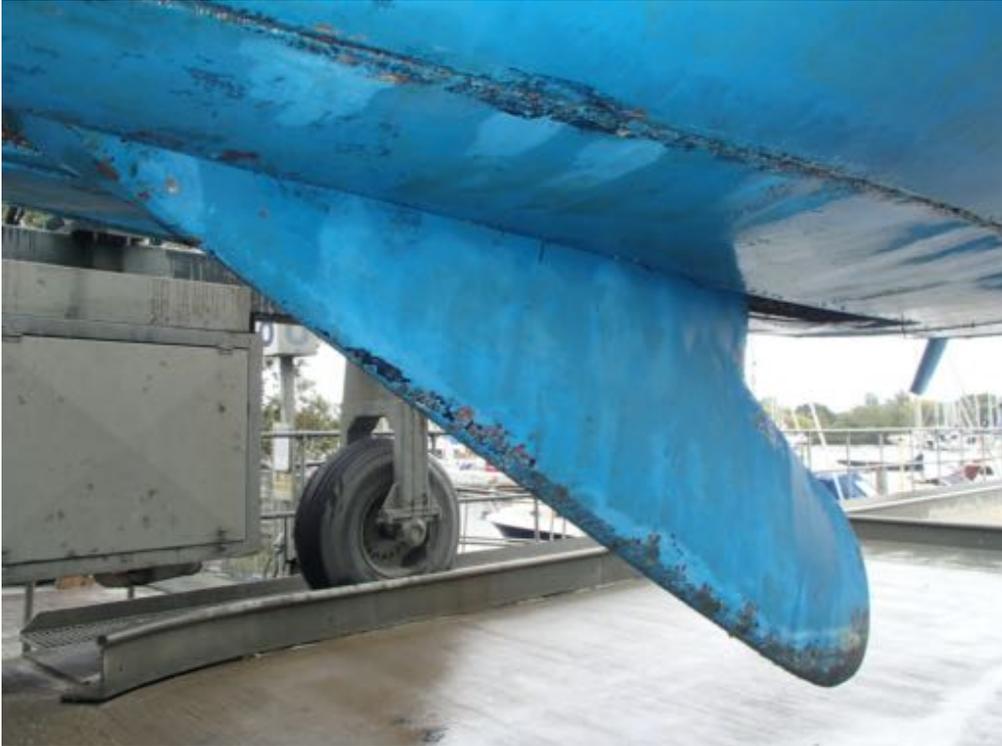
- b) With the vessel ashore the keel was left partially lowered. Access to the ram and cordage secured to the ram and the pivot point were concealed. The keel itself was without significant damage, although on the leading edge the keel corrosion was noted. Antifouling was absent from the leading edge and foot of the keel suggesting light grounding.

Image of the swing keel partially lowered. Note the surface corrosion developing and absence of antifouling on the leading edge and foot.

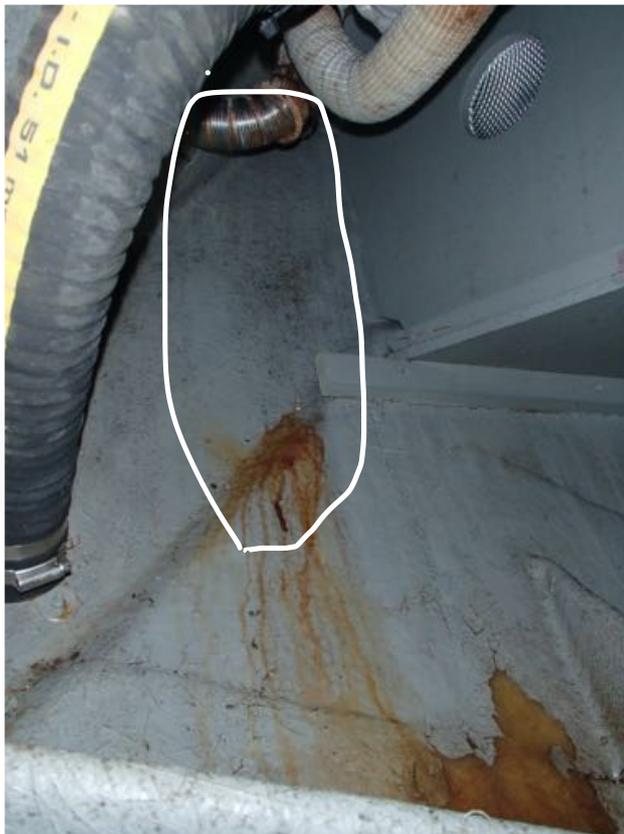
Image of a suspected leak from the heater exhaust or exhaust skin fitting

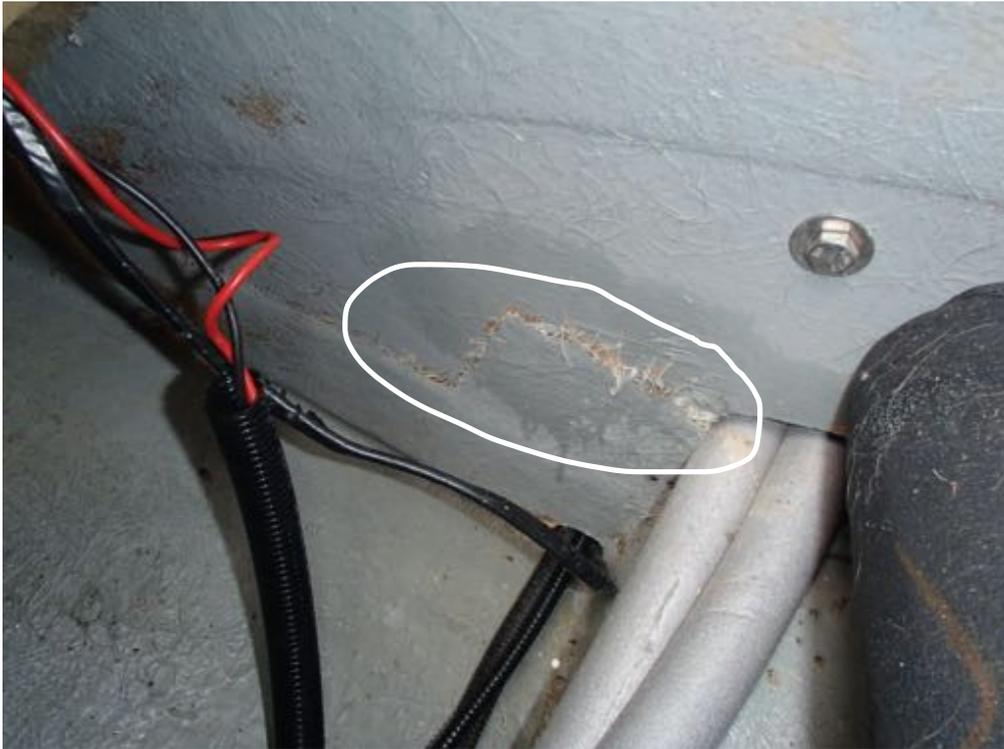
- b) Where accessible the bulkheads were noted to be intact and well secured to the adjoining hull and deck surfaces.
- c) Just forward of the fuel tank under the step down into the galley a small section of secondary bonding has de-bonded. This area while not structurally significant will require a small localised repair.

Image of a small section of the secondary bonding that has let go just forward of the fuel tank.

1. It is recommended that the small area of de-bonding noted under the step down into the galley forward of the fuel tank be ground back and re-laminated. (B)

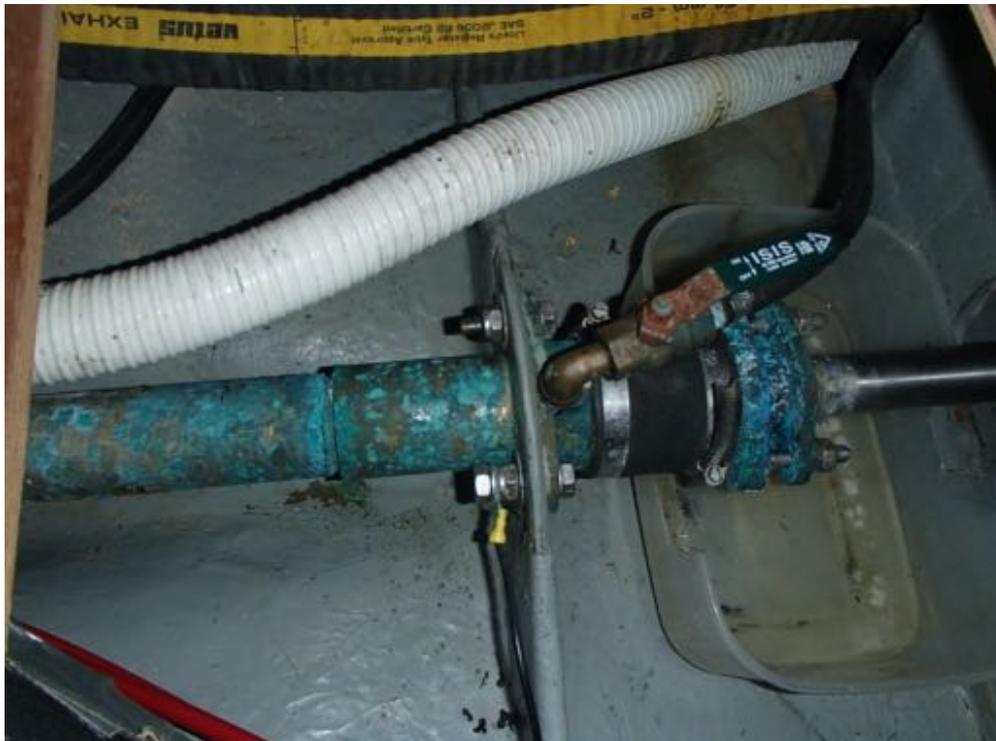
- e) The shaft seal is a water cooled packed seal. The seal is covered with surface corrosion and a plastic container under the seal suggest the seal is routinely weeping. These type of seals are known to 'drip' when the shaft is operating. The condition of the seal would suggest the seal is weeping more than designed. Servicing of the seal will be necessary.

Image of the shaft seal. Note the surface corrosion and the container under the seal suggesting a leak.

1. It is recommended that the shaft seal be serviced. (B)
